Report No.: JSASCN25918289 **Audit Date:** May 15-16, 2025

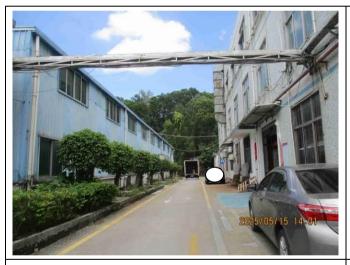
Factory name

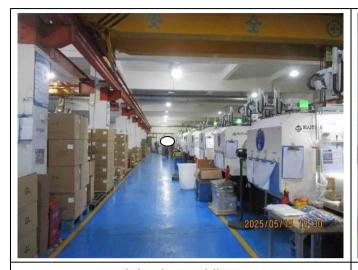
Injection molding

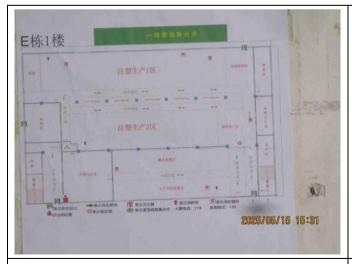
Evacuation plan map

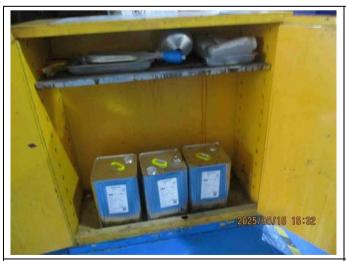
Chemical stored in explosion-proof cabinet

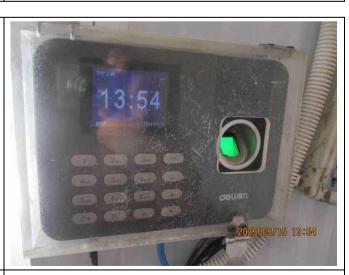
Attendance recorder

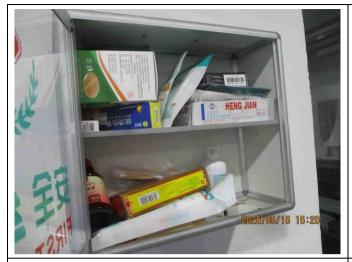
First aid kit

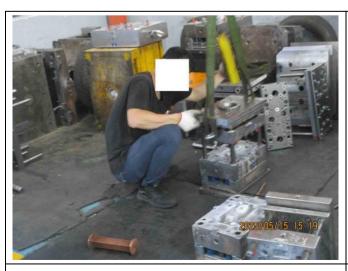
NC (7.6): The up and down moulds worker did not wear provided safety shoes and safety helmets.
